Lawrence Earley Construction Inc.

Property Inspection Report

Client(s): **Marty and Erica Harrison**
Property address: **130 Shores Blvd**
St Augustine FL 32086-7256
Inspection date: **Tuesday, December 31, 2024**

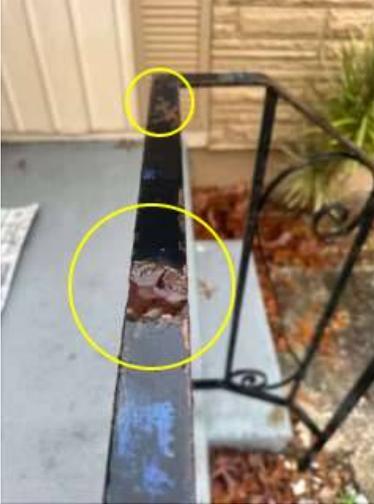
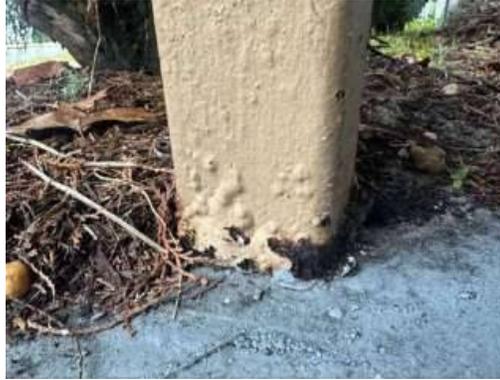
Carport support post is starting to rust at the bottom. Should be painted to prevent further rusting. Front porch hand rail is also starting to rust and should be painted.

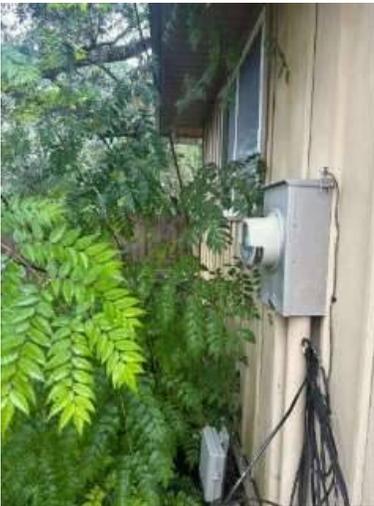
**Photo 4-1**

Vegetation was overgrown around equipment for one or more utilities such as gas or electric meters. Vegetation should be pruned or removed as necessary to allow unobstructed access.

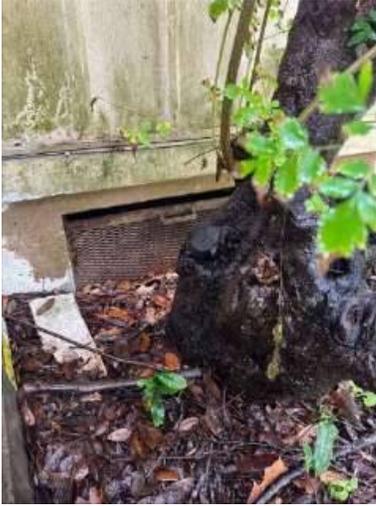
Photo 5-1

One or more large tree stumps were close to the building exterior. Wood-destroying insects such as carpenter ants nest in such stumps and are more likely to infest the building as a result. Recommend that large tree stumps within a few feet of the building be removed by a qualified tree service contractor.

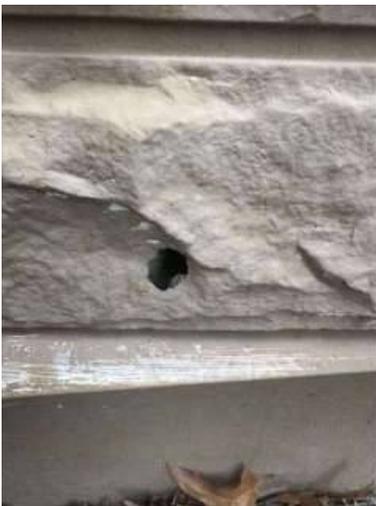
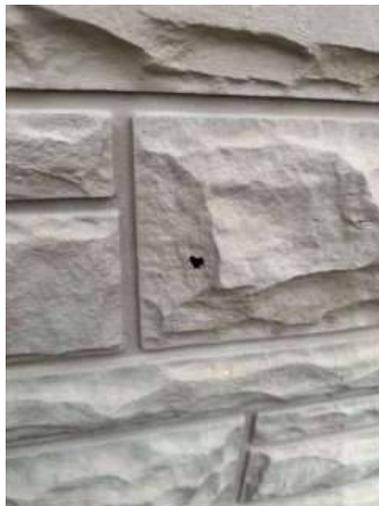
One or more holes or gaps were found in siding or trim. Vermin, insects or water may enter the structure. Recommend that a qualified person repair as necessary.

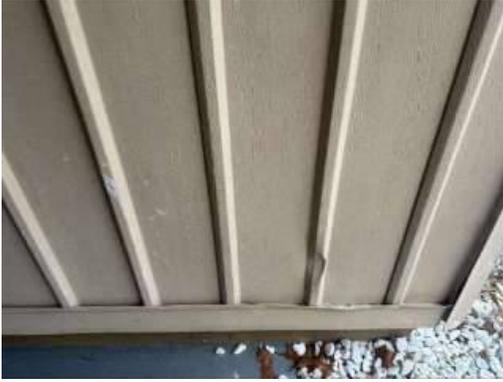
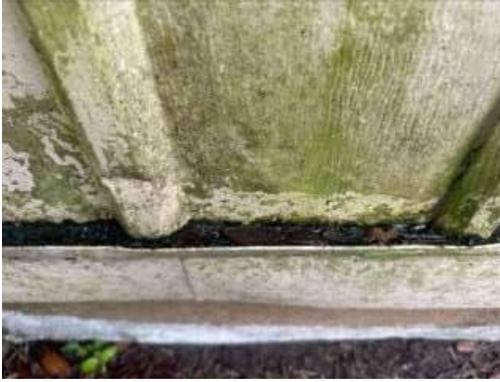
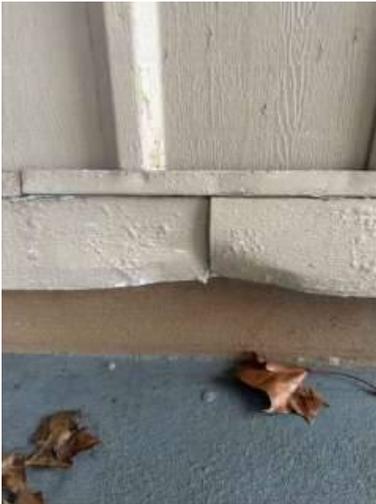
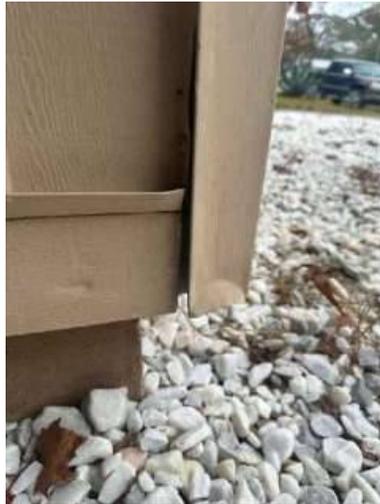
The aluminum siding is dented in some areas.

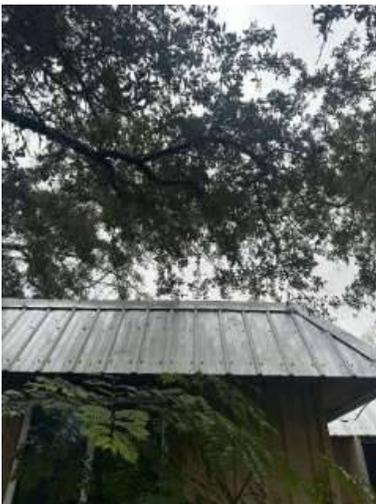
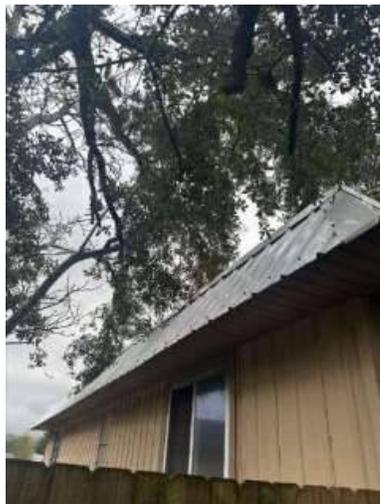
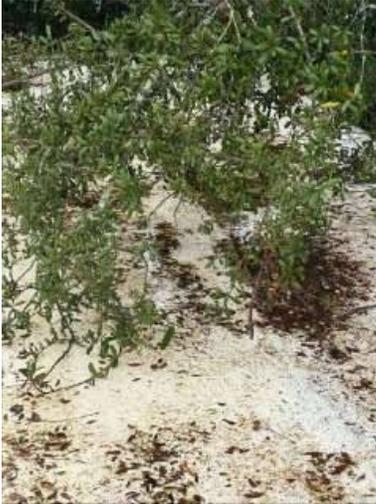
9) 🚧 Vegetation such as trees, shrubs and/or vines was in contact with or close to the building exterior. Vegetation can serve as a pathway for wood-destroying insects and can retain moisture against the exterior after it rains. This is a conducive condition for wood-destroying organisms. Recommend pruning, moving or removing vegetation as necessary to maintain at least 6 inches of space between it and the building exterior. A 1-foot clearance is better.

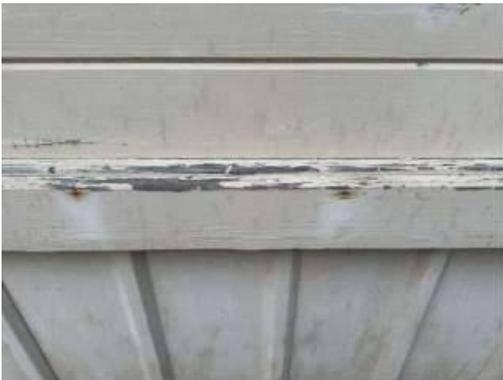
Photo 10-1

The paint or stain finish in some areas was failing (e.g. peeling, faded, worn, thinning). Siding and trim with a failing finish can be damaged by moisture. Recommend that a qualified contractor prep (e.g. clean, scrape, sand, prime, caulk) and repaint or restain the building exterior where necessary and per standard building practices. Any repairs needed to the siding or trim should be made prior to this.

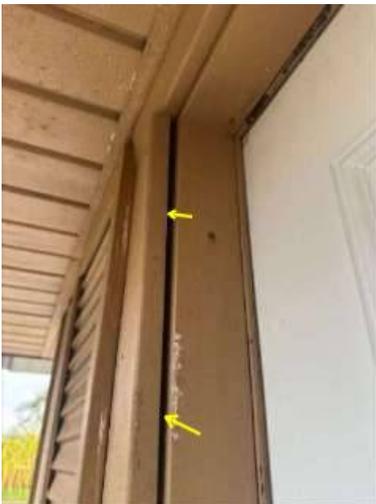
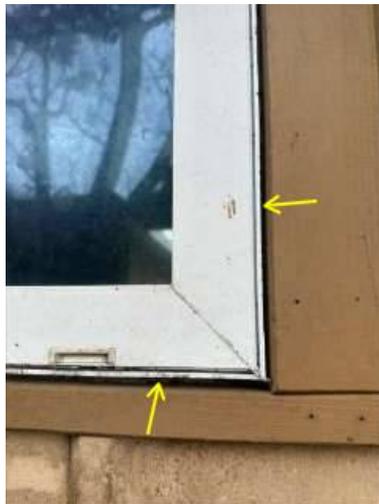
Caulk was missing in some areas. For example, around windows. Recommend that a qualified person renew or install caulk as necessary. Where gaps are wider than 1/4 inch, an appropriate material other than caulk should be used. For more information, visit:

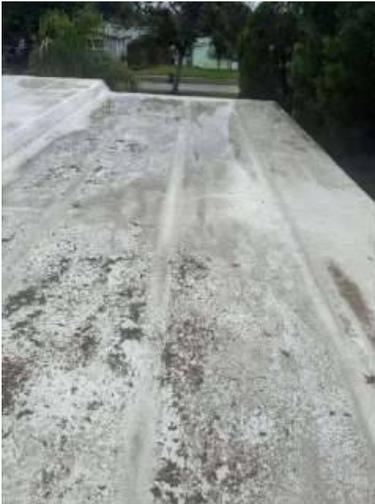
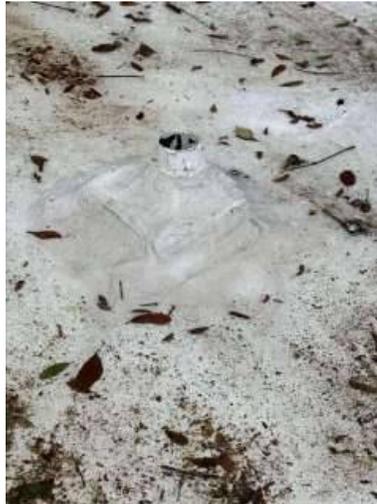
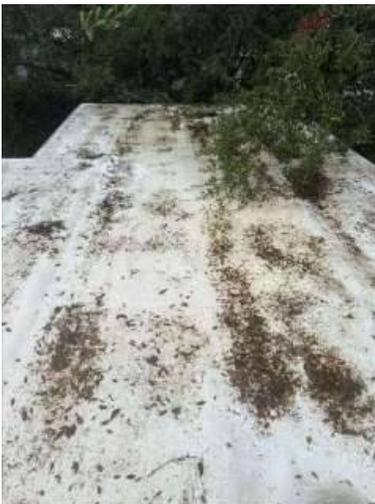
Ponding (pools of standing water) was found at one or more locations on the flat or low-slope roof surface. Even on a flat roof, water should be removed by a drainage system so that any remaining water evaporates within 48 hours after it rains. Prolonged standing water can result in roof leaks. This is a conducive condition for wood-destroying organisms. Recommend that a qualified contractor evaluate and repair as necessary to prevent ponding. It was raining during the inspection and there was standing water that was not draining. Monitor the area after a heavy rain.

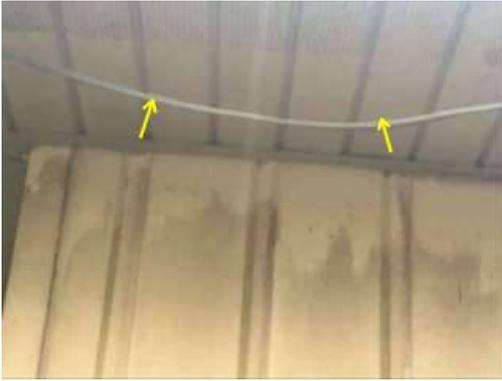
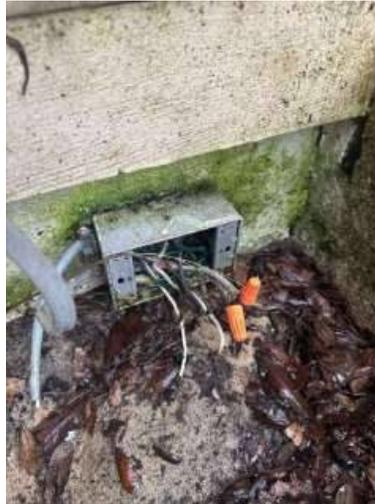
Substandard wiring was found at the building exterior. For example, exposed wiring, exposed splices and/or missing cover plates. This is a

safety hazard. Recommend that a qualified electrician evaluate and repair as necessary and per standard building practices.

The wires in the exterior junction box are "hot" energized wires and need to be covered. One wire at the back of the house is not secured to the building.

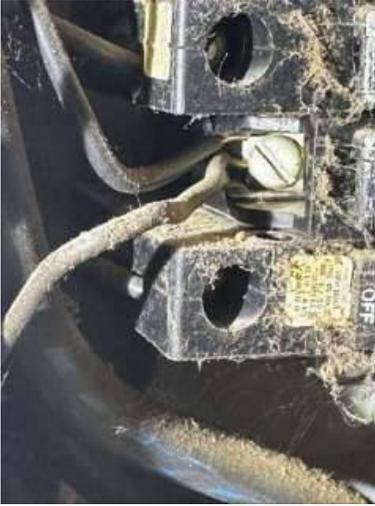
Photo 18-1

One or more circuit breakers in panel(s) #A were "double tapped," where two or more wires were installed in the breaker's lug. Most breakers are designed for only one wire to be connected. This is a safety hazard since the lug bolt can tighten securely against one wire but leave other(s) loose. Arcing, sparks and fires can result. Recommend that a qualified electrician repair as necessary. For more information, visit:

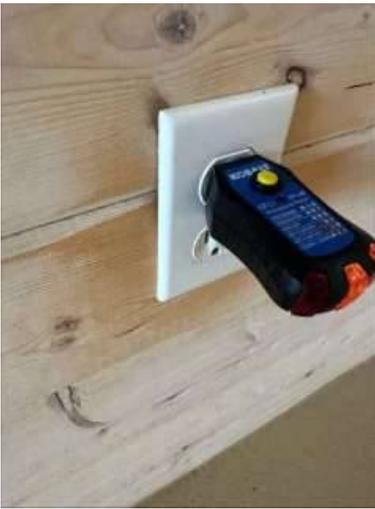
Photo 19-1

One or more electric receptacles (outlets) and/or the boxes in which they were installed were loose and/or not securely anchored. Wire conductors can be damaged due to repeated movement and/or tension on wires, or insulation can be damaged. This is a shock and fire hazard. Recommend that a qualified electrician repair as necessary.

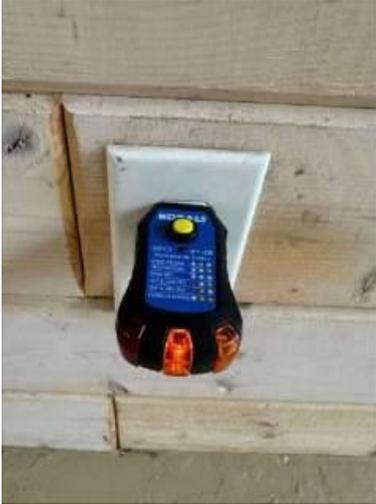
Photo 20-1

One or more modern, 3-slot electric receptacles (outlets) were found with an open ground. This is a shock hazard when appliances that require a ground are used with these receptacles. Examples of such appliances include computers and related hardware, refrigerators, freezers, portable air conditioners, clothes washers, aquarium pumps, and electrically operated gardening tools. Recommend that a qualified electrician repair as necessary so all receptacles are grounded per standard building practices. Open ground on outlets next to the kitchen.

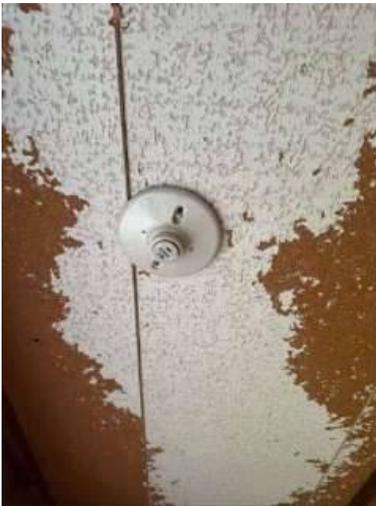
Photo 21-1

Lighting was missing at one or more closets. For safety and convenience, recommend that a qualified electrician install lighting as necessary, and per standard building practices.

Exterior closet light bulb missing.

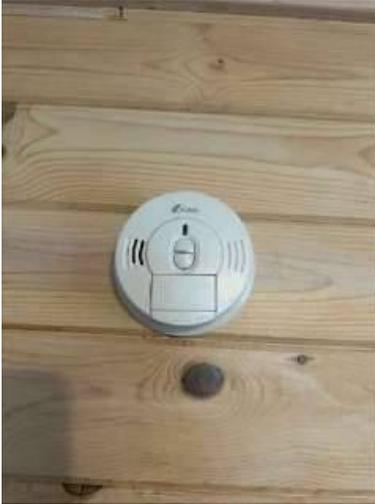
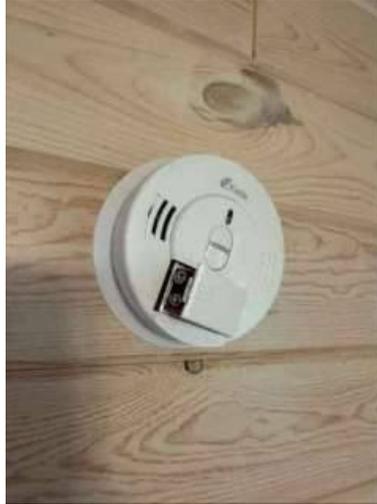
Batteries in all the smoke alarms should be replaced after taking occupancy, and annually in the future. "Chirping" noises emitted from smoke alarms typically indicate that batteries need replacing. For more information, visit:

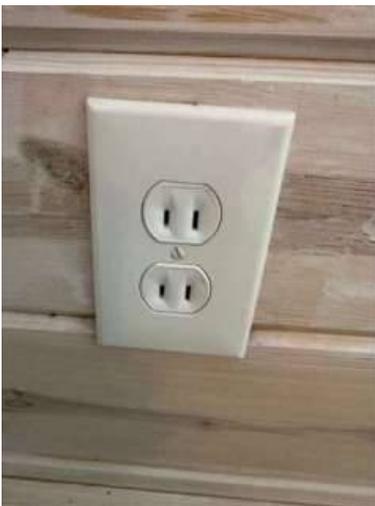
Photo 24-1

2-slot receptacles (outlets) rather than 3-slot, grounded receptacles were installed in one or more areas. These do not have an equipment ground and are considered unsafe by today's standards. Appliances that require a ground should not be used with 2-slot receptacles. Examples of such appliances include computers and related hardware, refrigerators, freezers, portable air conditioners, clothes washers, aquarium pumps, and electrically operated gardening tools. The client should be aware of this limitation when planning use for various rooms, such as an office. Upgrading to grounded receptacles typically requires installing new wiring from the main service panel or sub-panel to the receptacle(s), in addition to replacing the receptacle(s). Consult with a qualified electrician about upgrading to 3-wire, grounded circuits.

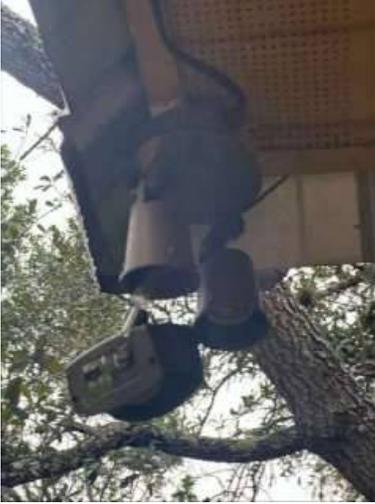
Photo 25-1

Missing bulbs from exterior flood light.

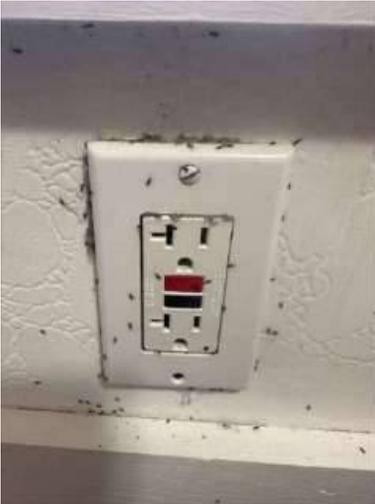
Photo 26-1

Termites are coming from the bathroom GFCI outlet.

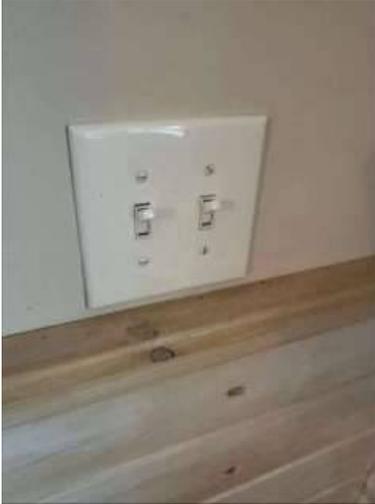
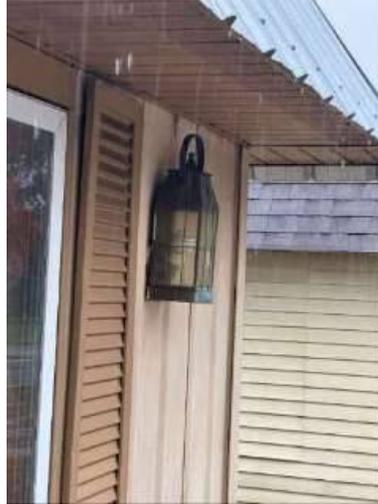
One or more light fixtures were inoperable (didn't turn on when nearby switches were operated). Recommend further evaluation by replacing bulbs and/or consulting with the property owner. If replacing bulbs doesn't work and/or no other switch(es) can be found, then recommend that a qualified electrician evaluate and repair or replace light fixtures as necessary.

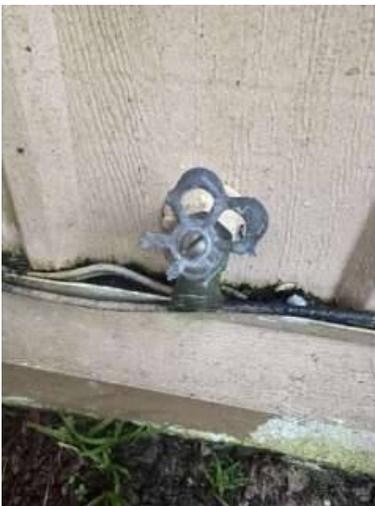
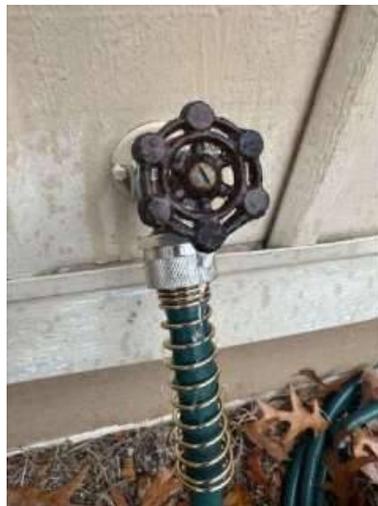
The exterior hose bib at the front of the house leaks, and the one at the back of the house has a broken handle and is stuck shut.

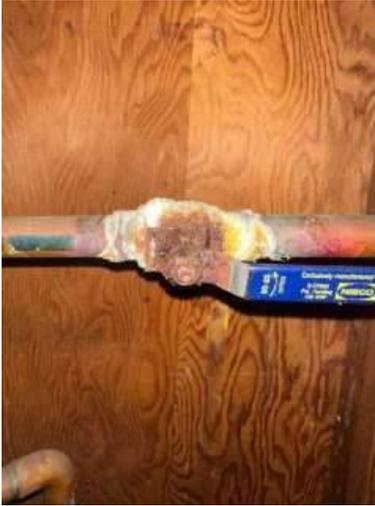
Photo 29-1

Significant corrosion or rust was found at the shut-off valve. This can indicate past leaks, or that leaks are likely to occur in the future. Recommend that a qualified plumber evaluate and replace components or make repairs as necessary.

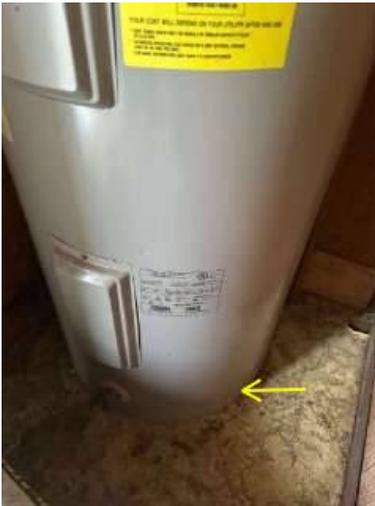
Photo 30-1

The water heater was installed in an unheated space on a concrete floor and was not resting on an insulated pad. The bottom of the casing is likely to rust, and energy efficiency may be reduced. Recommend installing an insulated pad under the water heater.

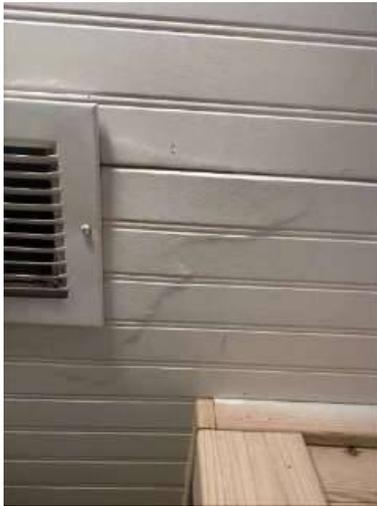
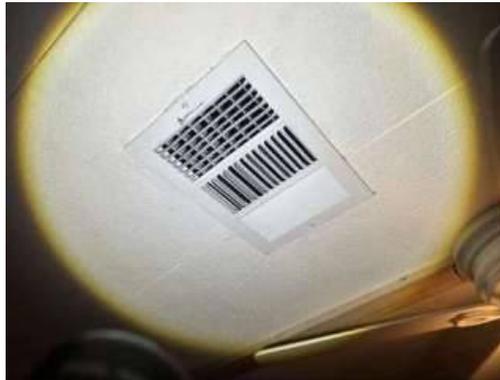
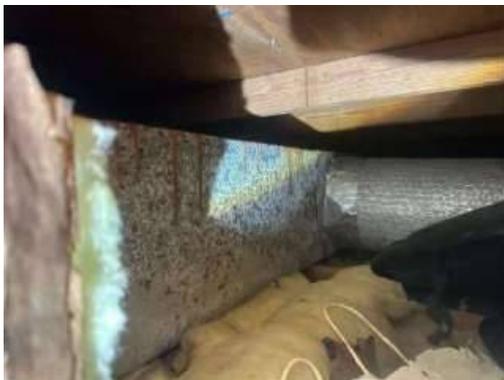
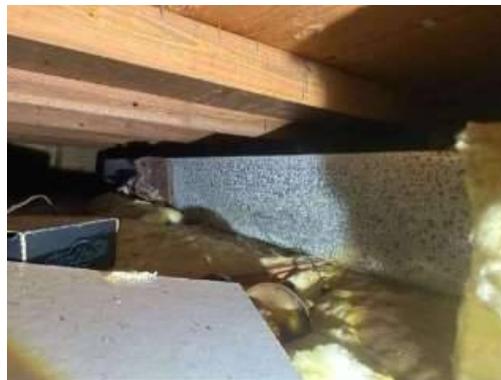
One or more heating or cooling ducts in an unconditioned space (e.g. crawl space, attic or basement) were not insulated, or the insulation was damaged or deteriorated. This can result in reduced energy efficiency, moisture inside heating ducts, and/or "sweating" on cooling ducts. Recommend that a qualified person repair per standard building practices. For example, by wrapping ducts in insulation with an R-value of R-8.

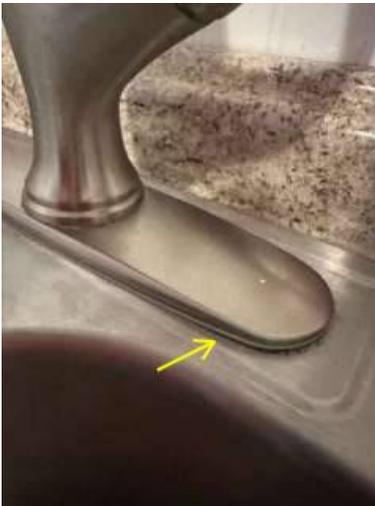
Photo 34-1

The sink faucet was loose. Recommend that a qualified person repair as necessary.

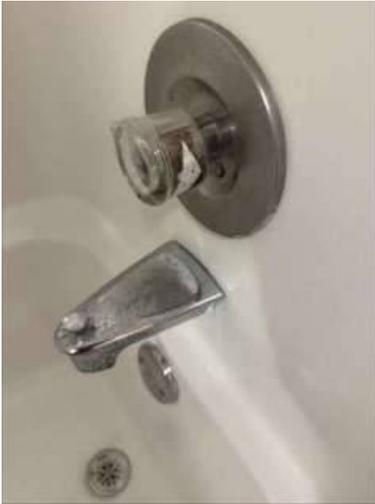
Photo 36-1

One or more bathtub faucet handles at location(s) #A were loose. Recommend that a qualified person repair or replace handles as necessary.

The handle and downspout need to be secured inside the wall. They pull in and out.

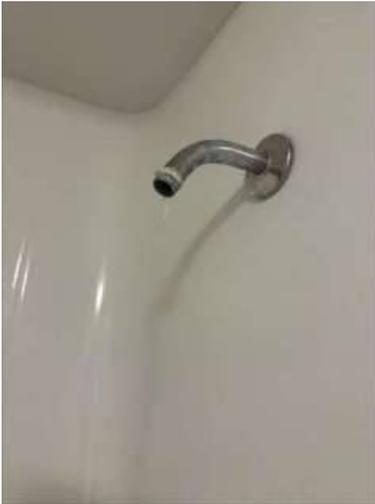
Photo 37-1

37) The shower head is missing.

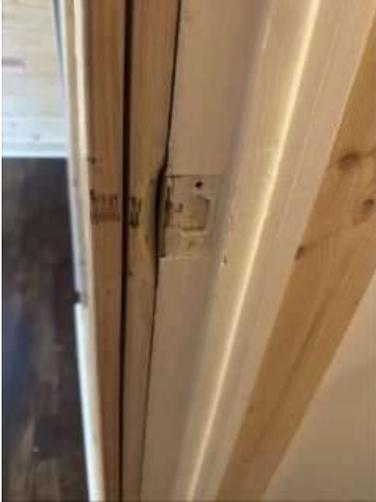
Photo 39-1

39) 🛠️ Some interior door hardware (strike plates) were missing. Recommend that a qualified person repair or replace as necessary.

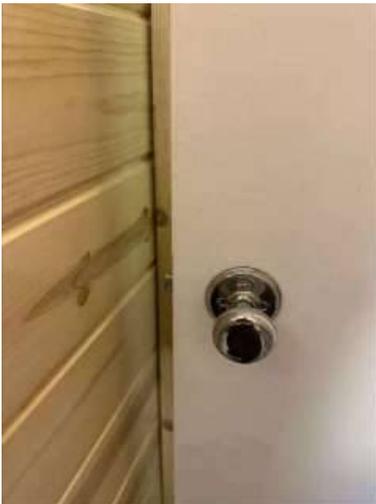
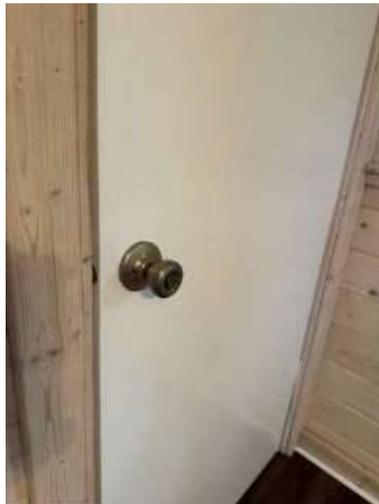
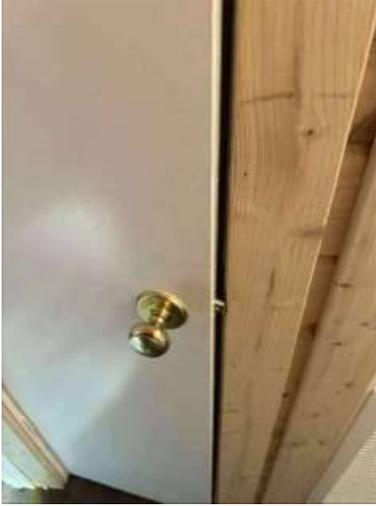
40) 🛠️ One or more interior doors wouldn't latch or were difficult to latch. Recommend that a qualified person repair as necessary. For example, by adjusting latch plates or locksets. 3 doors did not latch.

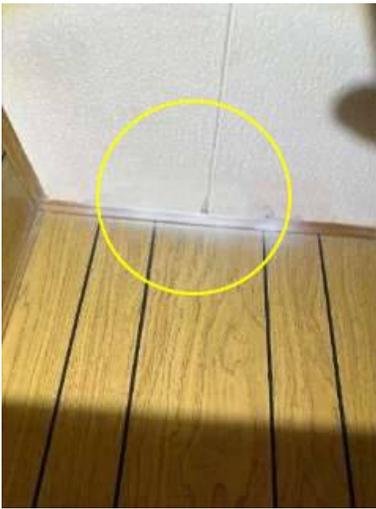
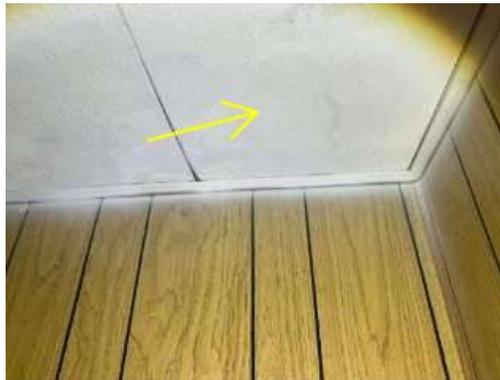
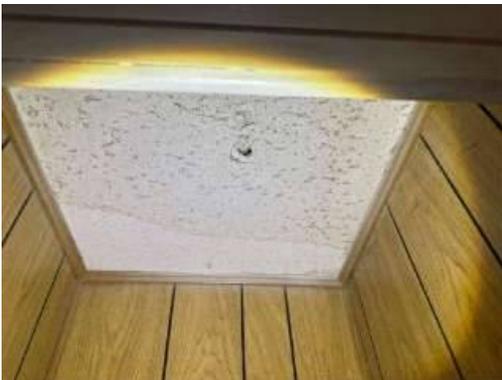
Stains were found in one or more ceiling areas. However, no elevated levels of moisture were found. The stain(s) may be due to past roof and/or plumbing leaks. Consult with the property owner and monitor the stained area(s) in the future, especially after heavy or prolonged rain. If elevated moisture is found in the future, then recommend that a qualified contractor evaluate and repair as necessary.

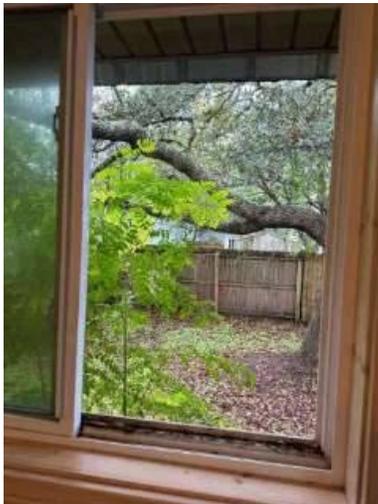
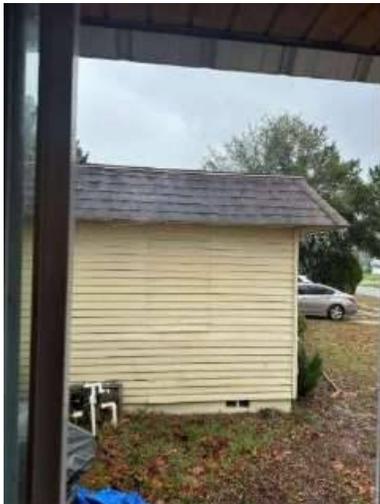
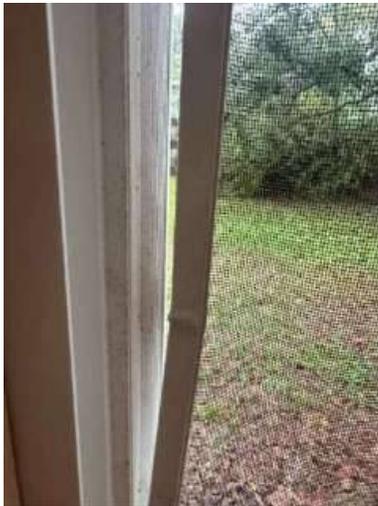
Screens were missing from some windows. These windows may not provide ventilation during months when insects are active.

3 Missing screens.

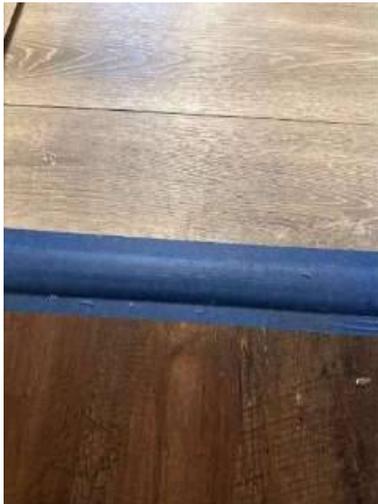
Photo 43-1

43) Missing threshold transition into bathroom.
